TEST REPORT

No. : XMIN170601032CCM

Sample Name : RECLAIMED WILD OAK (WOOD)
Buyer : AIRSTEP FLOORING

Slip resistance (oil-wet ramp test)

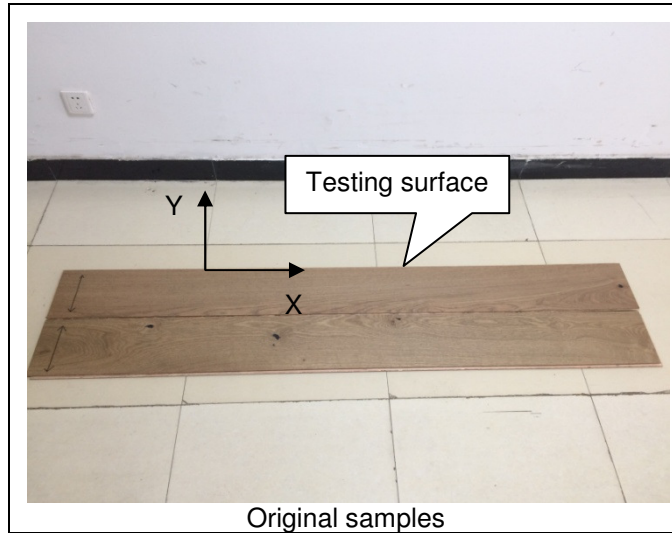
Specimen photograph:

Flooring, 5pcs of test samples 500mm×190mm (which were cut from original samples) form a testing surface of 500mm×950mm, see the photo(s)

Original samples

Testing surface: see the photo(s)
