# Impact Sound Insulation Measurement

Airstep Australia Pty Ltd  
'3 mm Vinyl Planks' on 'Helix' Underlay

REPORT No  
**7554-1.2R**

DATE ISSUED  
**30 June 2022**

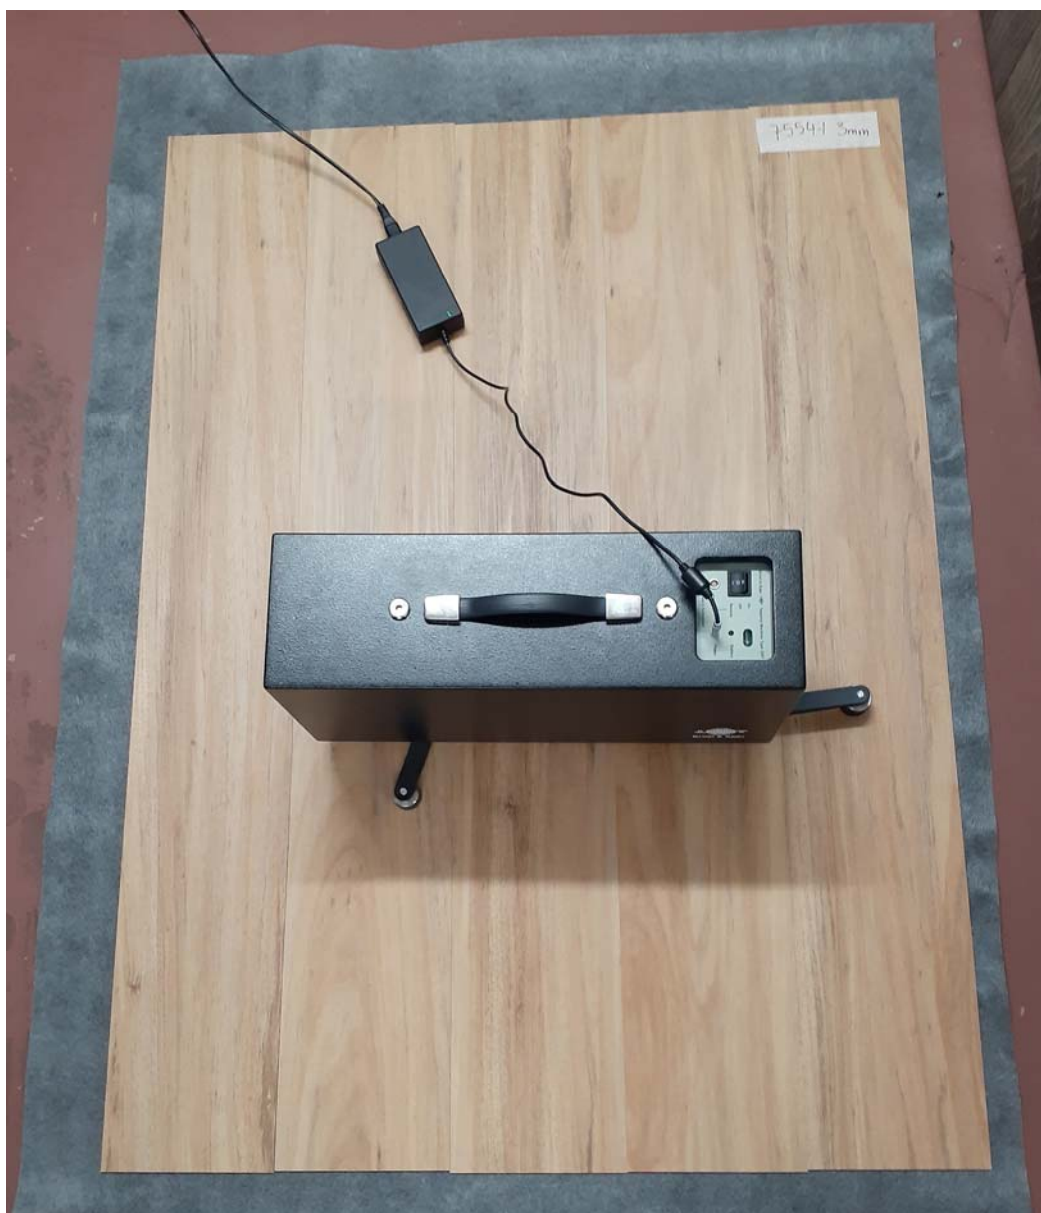
**Figure 2. Image of testing configuration - '3 mm Vinyl Planks' with 'Helix' underlay on base floor**

The test sample of 3 mm thick 'Vinyl Planks' was placed on top of 2 mm thick 'Helix' underlay, setup on top of the base floor as shown in Figure 2.

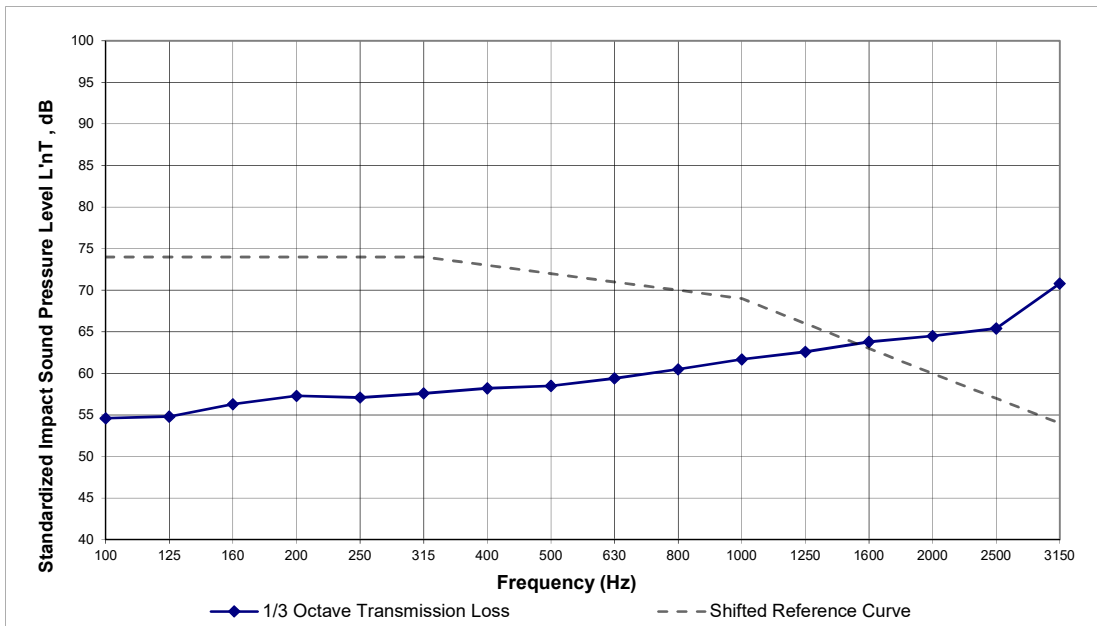
Project Number: 7554-1 A001

Bare Slab

Building Construction  
270 mm concrete slab

| Frequency - Hz | Standardised Impact Sound Pressure Level<br>1/3 Octave dB |
|---|---|
| <b>L' nT,w</b> | <b>72</b> |

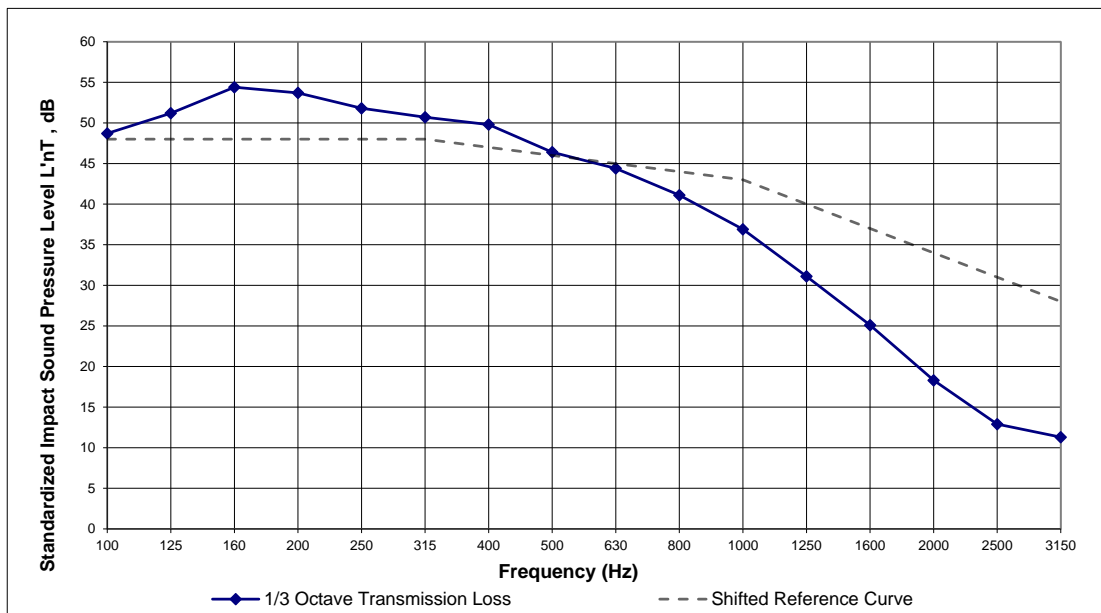
Project Number: 7554-1 A003

**3 mm Vinyl Planks + Helix Underlay**

270 mm concrete slab

| Frequency - Hz | Standardised Impact Sound Pressure Level<br>1/3 Octave dB |
|---|---|
| <b>L' nT,w</b> | <b>46</b> |

The floor/ceiling system of the 3 mm thick 'Vinyl Planks' with 'Helix' underlay laid on top of a base floor construction of 270 mm concrete, achieved a weighted impact sound insulation rating of  $L'_{nT,w}$  of 46, improving the base floor performance by  $L'_{nT,w}$  of 26 dB.
