# Impact Sound Insulation Measurement

Airstep Australia Pty Ltd  
'4 mm Vinyl Planks' on 'Helix' Underlay

REPORT No  
**7554-1.3R**

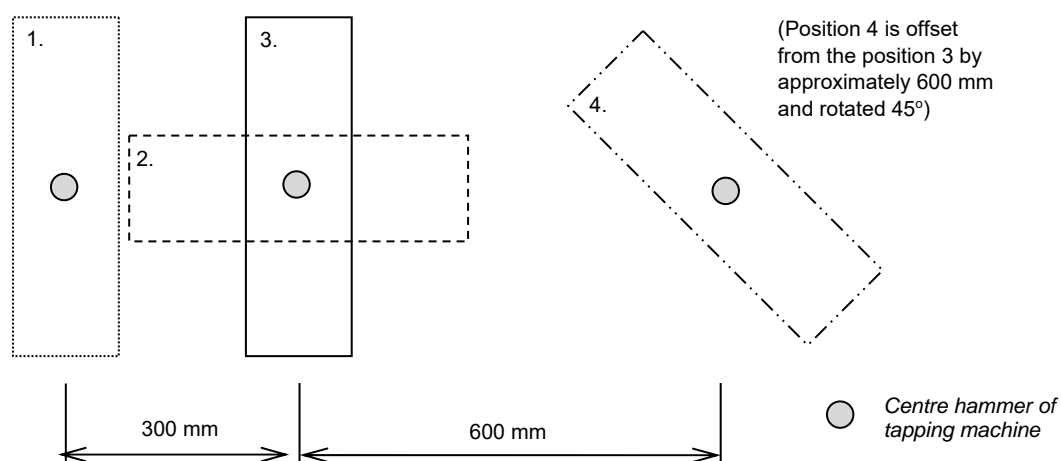
**Figure 1. Tapping machine test orientations**

The tapping machine is placed in 4 orientations as shown in Figure 1 below.

Impact noise levels in the receiving room are measured using the microphone sweep method for a period of 30 seconds per tapping machine orientation.

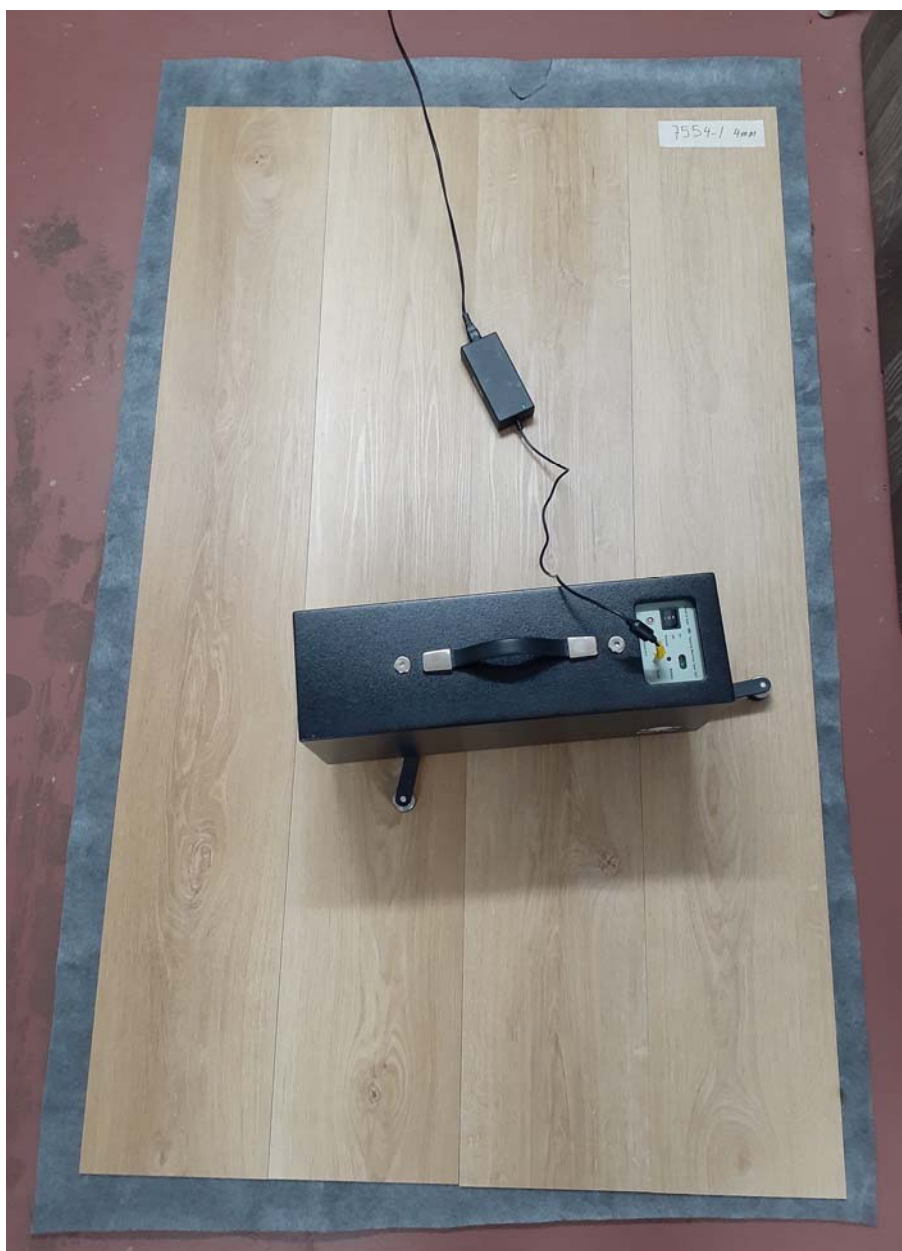
**Figure 2. Image of testing configuration - '4 mm Vinyl Planks' with 'Helix' underlay on base floor**

The test sample of 4 mm thick 'Vinyl Planks' was placed on top of 2 mm thick 'Helix' underlay, setup on top of the base floor as shown in Figure 2.

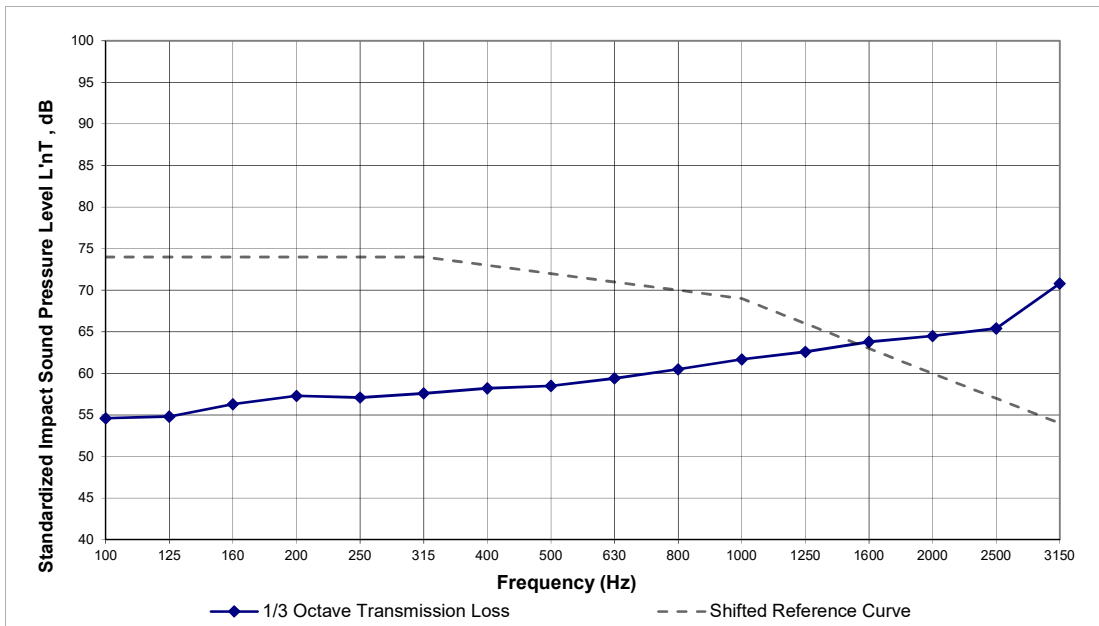
Project Number: 7554-1 A001

Bare Slab

Building Construction  
270 mm concrete slab

| Frequency - Hz | Standardised Impact Sound Pressure Level<br>1/3 Octave dB |
|---|---|
| <b>L' nT,w</b> | <b>72</b> |

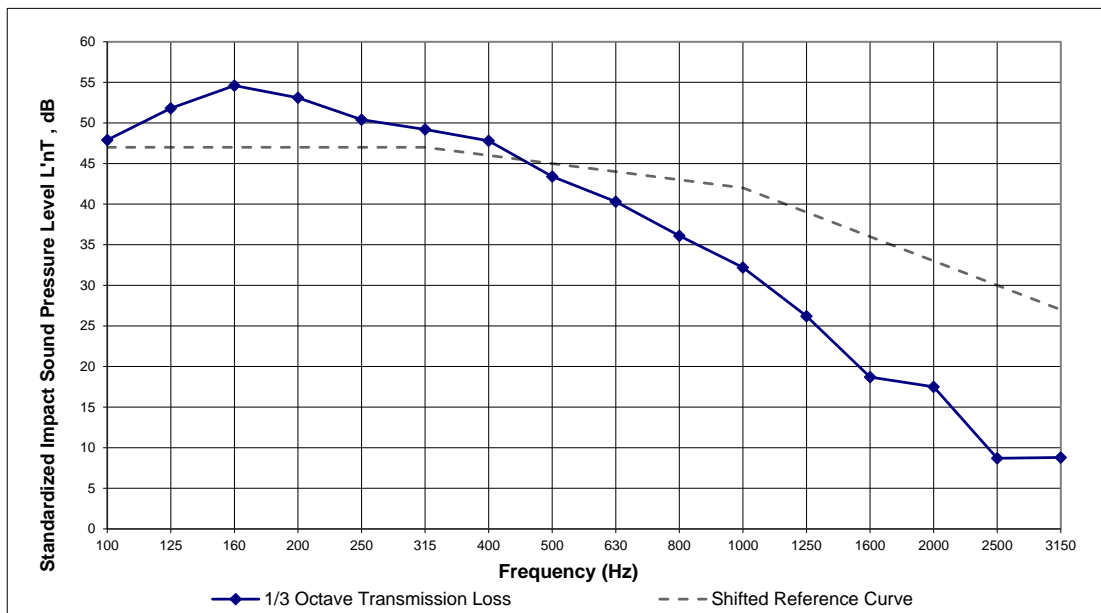
Project Number: 7554-1 A004

**4.5 mm Vinyl Planks + Helix Underlay**

270 mm concrete slab

| Frequency - Hz | Standardised Impact Sound Pressure Level<br>1/3 Octave dB |
|---|---|
| <b>L' nT,w</b> | <b>45</b> |

The floor/ceiling system of the 4 mm thick 'Vinyl Planks' with 'Helix' underlay laid on top of a base floor construction of 270 mm concrete, achieved a weighted impact sound insulation rating of  $L'_{nT,w}$  of 45, improving the base floor performance by  $L'_{nT,w}$  of 27 dB.
