Impact Sound Insulation Measurement

Airstep Australia Pty Ltd Reclaimed Wild Oak with 'Timbermax' Underlay

REPORT No **6124-2.4R**

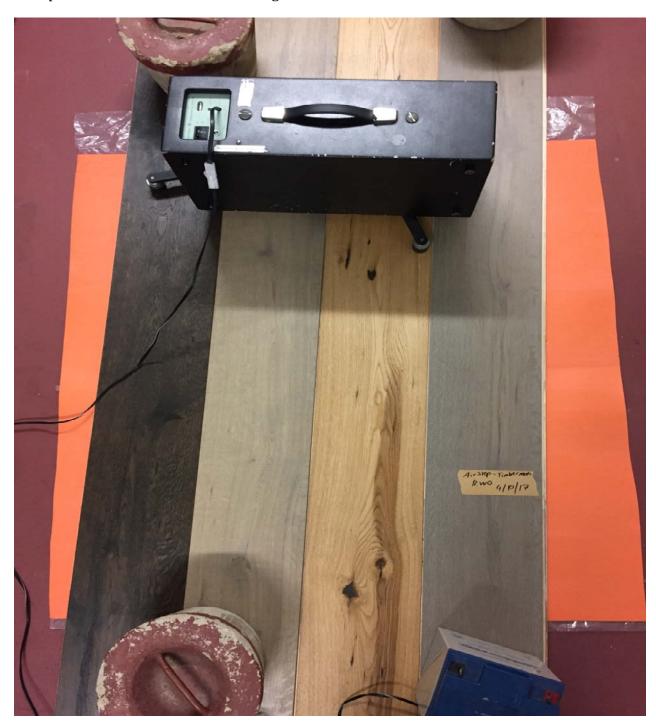
Figure 2. Setup of 'Timbermax' underlay with reclaimed Wild Oak floorboards.

The base floor (see Section 2.0) was tested to establish a reference performance of the floor/ceiling system from which the test sample is compared to. The test sample of 14 mm Reclaimed Wild Oak timber floorboards was laid on top of the 'Timbermax' underlay and setup on top of the base floor as shown in Figure 2 below.
